# Commercial Roof Inspection Report

Aerial visual documentation and qualitative infrared thermography for commercial roof systems.

Sample Commercial Property

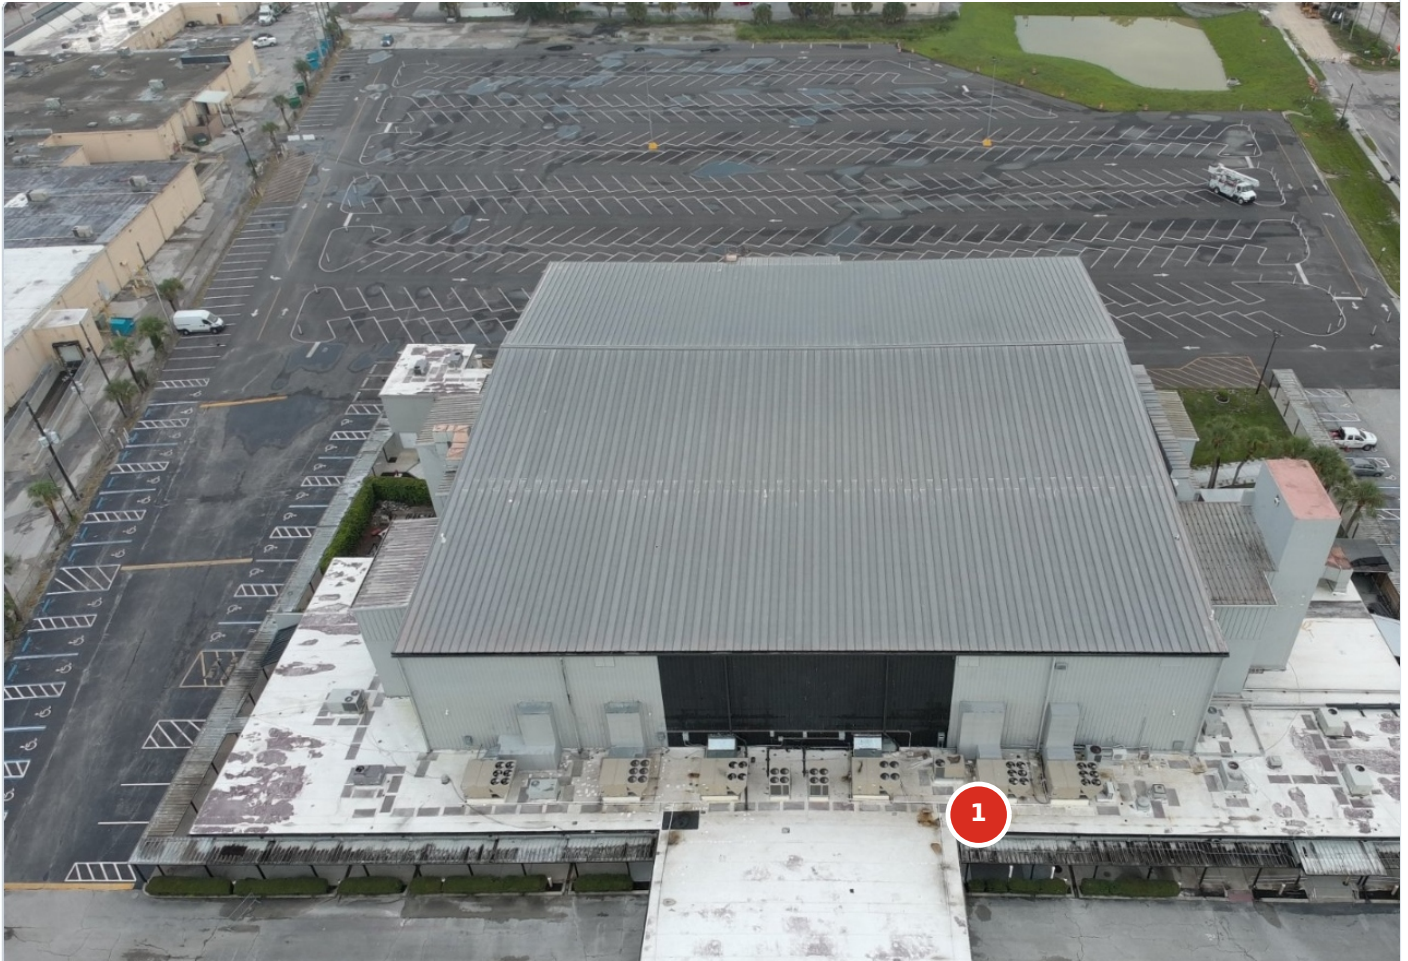
1

## Reported leak location

No definitive thermal anomaly was observed at the time of the morning inspection. Limited temperature differential and the silicone roof coating reduced thermal contrast, so the presence or absence of subsurface moisture could not be conclusively determined.

**VERIFICATION RECOMMENDED**

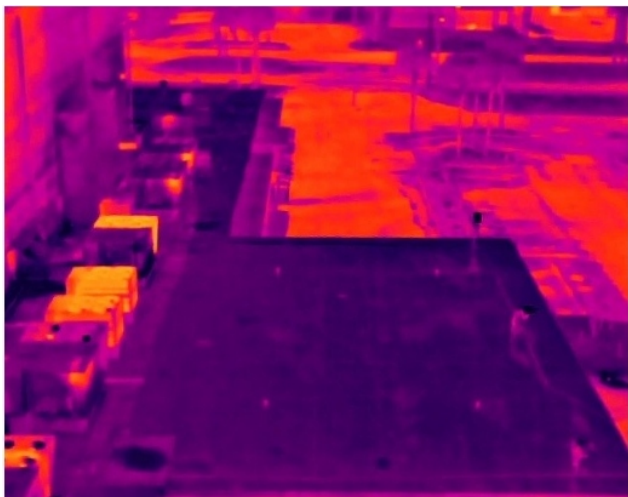
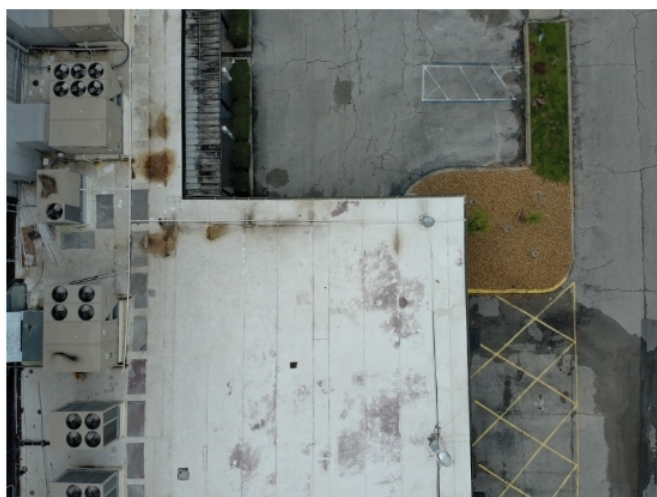
**FINDING 01**

**LOW SEVERITY**

**AREA OF CONCERN**

A known leak area was documented. No definitive thermal anomaly was visible during the survey, but limited morning temperature differential and the existing silicone coating reduced the effectiveness of infrared interpretation at this location.

Conduct a follow-up infrared inspection under more favorable conditions, ideally late afternoon or evening after adequate solar loading. Obtain a roof core sample at or adjacent to the location to verify the roofing assembly and determine whether trapped moisture is present. Complete repairs based on supplemental testing results.
